The Effectiveness of Alluvial Gully Remediation in Great Barrier Reef Catchments

Supported by the Australian Government's
National Environmental Science Program

Project 3.1.7 Reducing sediment loads to the Great Barrier Reef: Developing optimal approaches for treating alluvial gully erosion

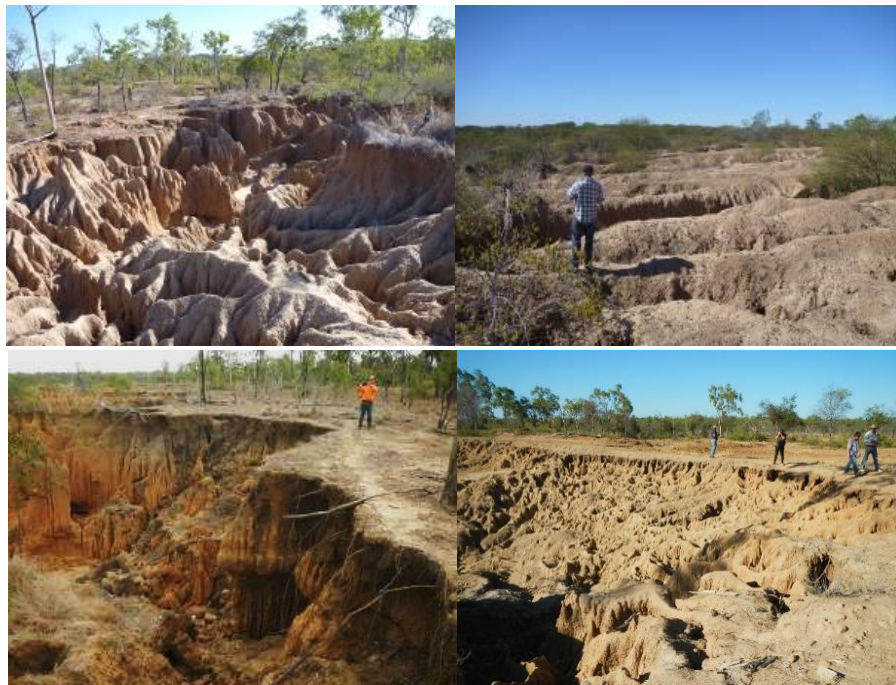
Figure 1. A selection of alluvial gullies from the Bowen catchment. (All photos Andrew Brooks except top right John Spencer)

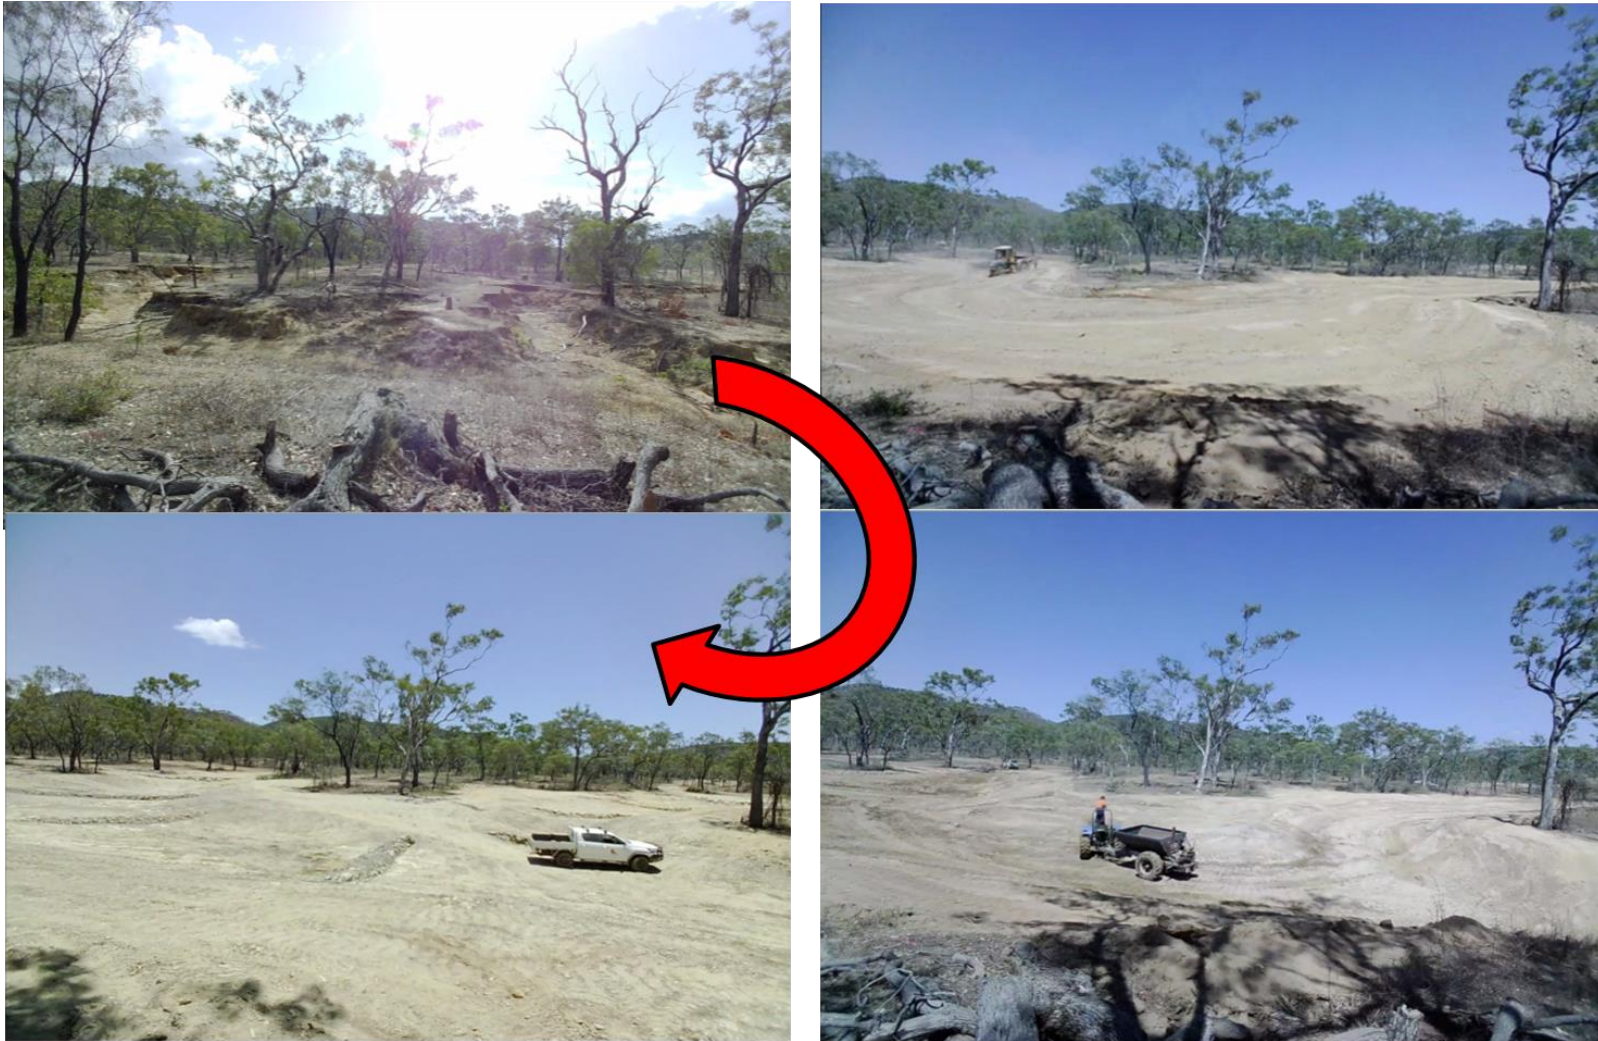
Figure 8. Time lapse sequence of construction at gully 2.234 in October, 2016

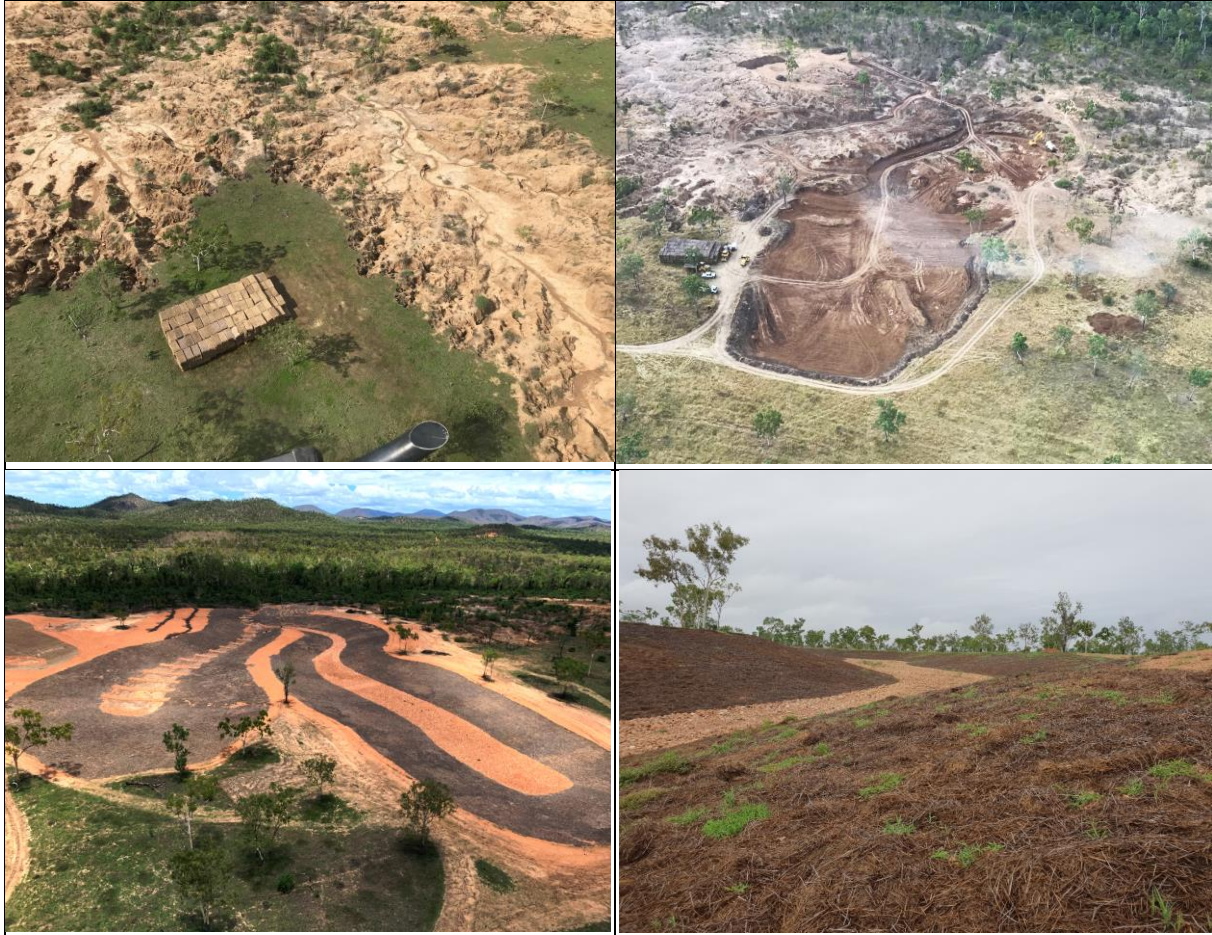
Figure 15. A selection of photographs showing the Strathalbyn Northern Gullies in various stages of construction, both before (top left), during (top right) and after (bottom). Note the trucks and excavators in the photo at the top right for scale. (photos top Damon Telfer - bottom Andrew Brooks).

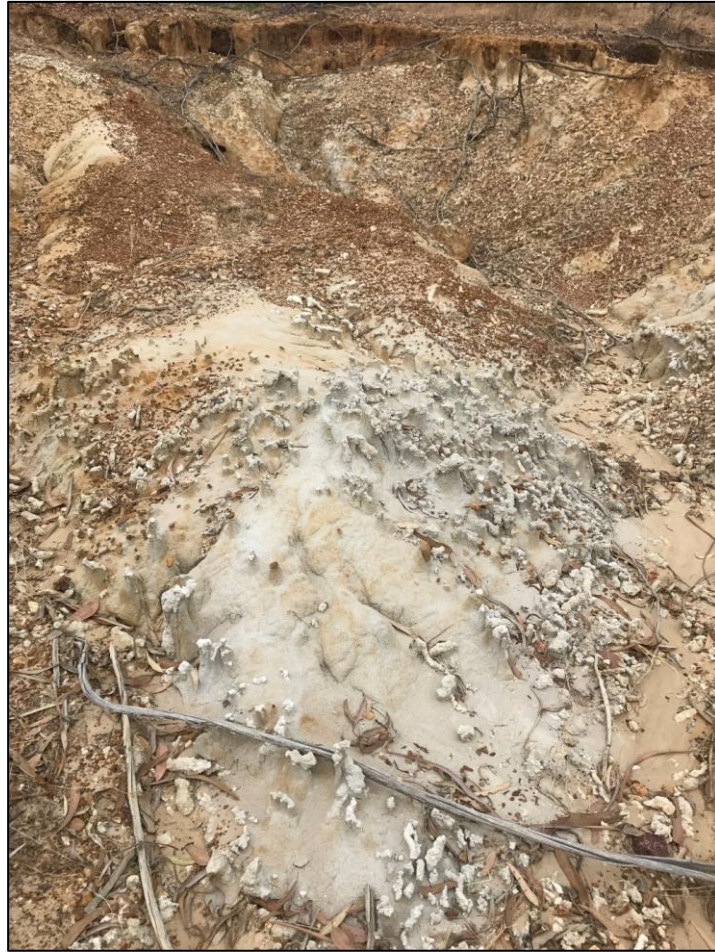
Figure 23. Gully walls and Interfluves in the southern end of study area in the ORR SMS cutting into the yellow sodic and mottled grey sodic layers of the OSF SMS. Iron nodules evident from original, now eroded, ferricrete, and the 'gully coral' of the lower grey mottled layers (calcified/dolomitized root channels).

The main gully erosion complex comprises several material layers of yellow brown to grey, mottled (with yellow, orange, red and grey) fine sandy clays and sandy clays (OSF SMS). An example of these is shown in Figure 22, with almost a full suite of the SMUs found in the OSF SMS. These are sometimes topped with recent surface wash deposition, deep in places (0.4-0.5 m), with evidence of several periods of depositional events (laminations), with erosion in between. These surface materials are both sodic and magnesian. The subsurface layers usually exhibit sparse to dense carbonate nodules, occasionally to depths over a metre. These nodules are often enriched with magnesium to form a much denser dolomite mineral than the usual calcite. It is this dolomitic nodulation that forms the characteristic ‘coral’ of the southern gullies and Earl’s Creek from root channel mineralisation (Figure 23).

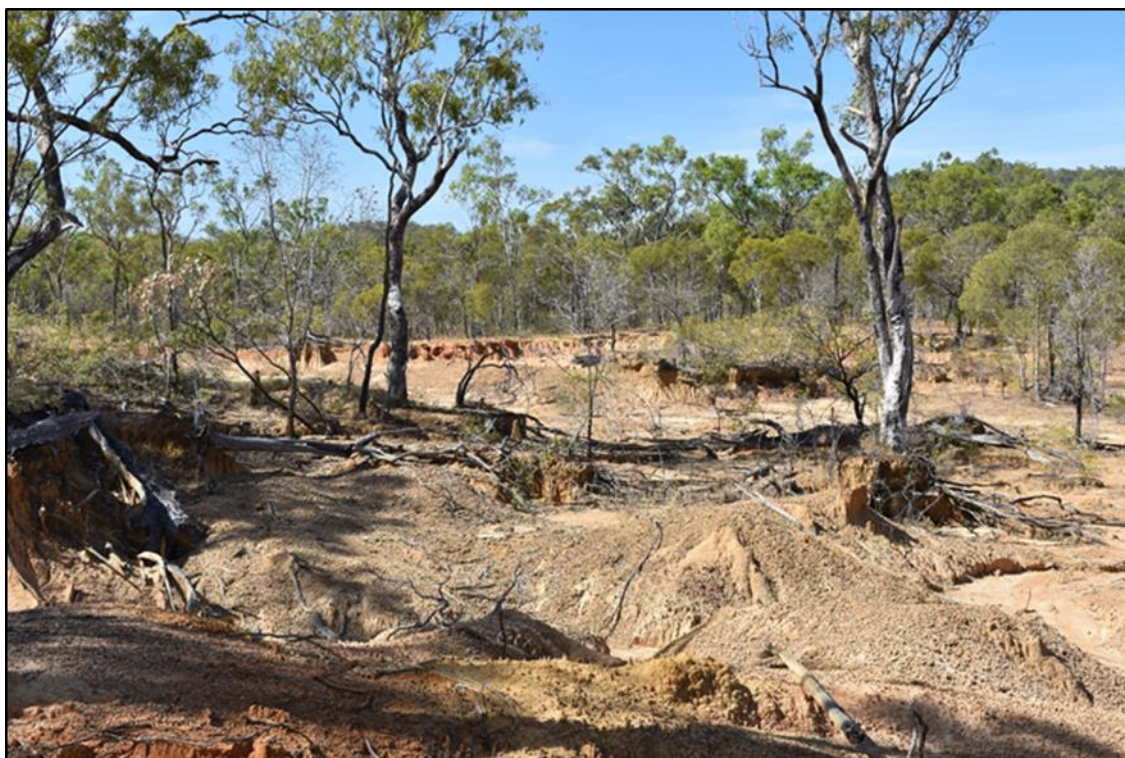
Figure 24. A typical example of the soil material layers in the OSF SMS, gully floors are semi-stable in places but most floor areas are reactivated.

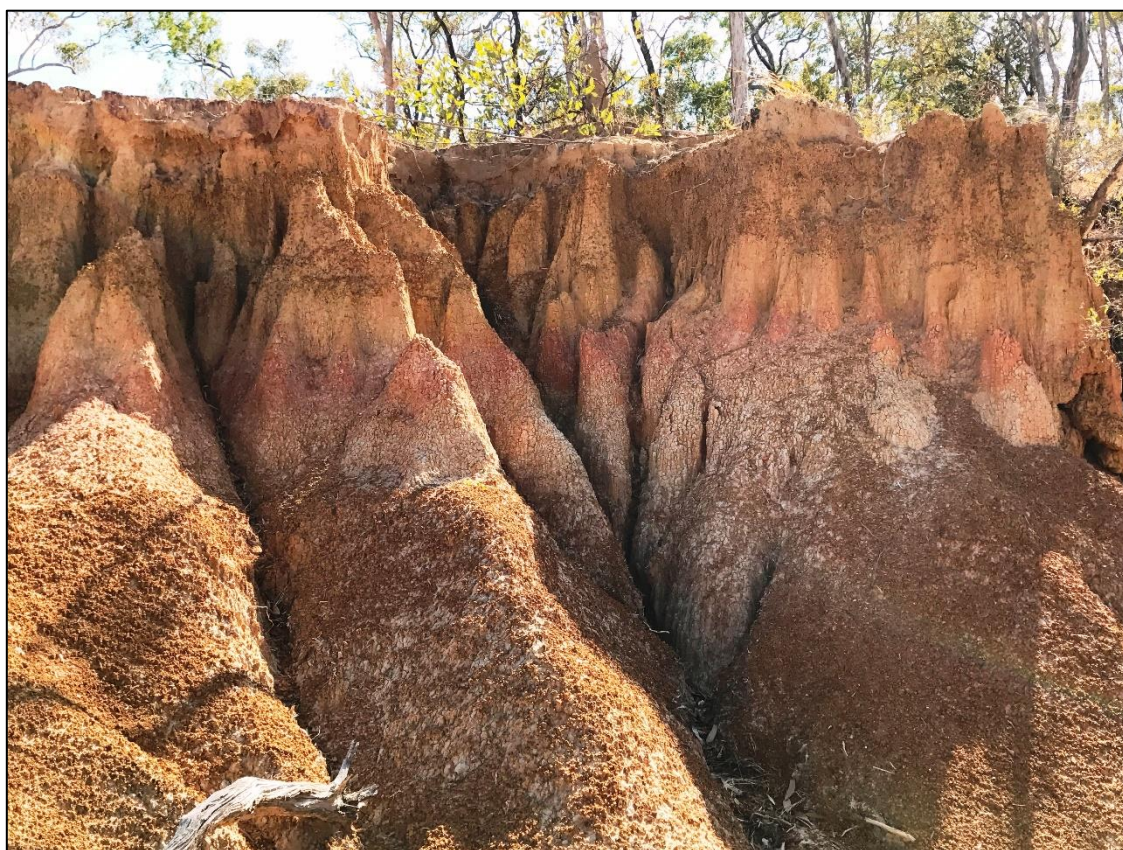
Figure 25. A gully wall in the southern end of the lateritic ORR SMS, showing the laterisation and ferricrete formation, as well as the extensive iron nodule coverings of the lower soil material layers.

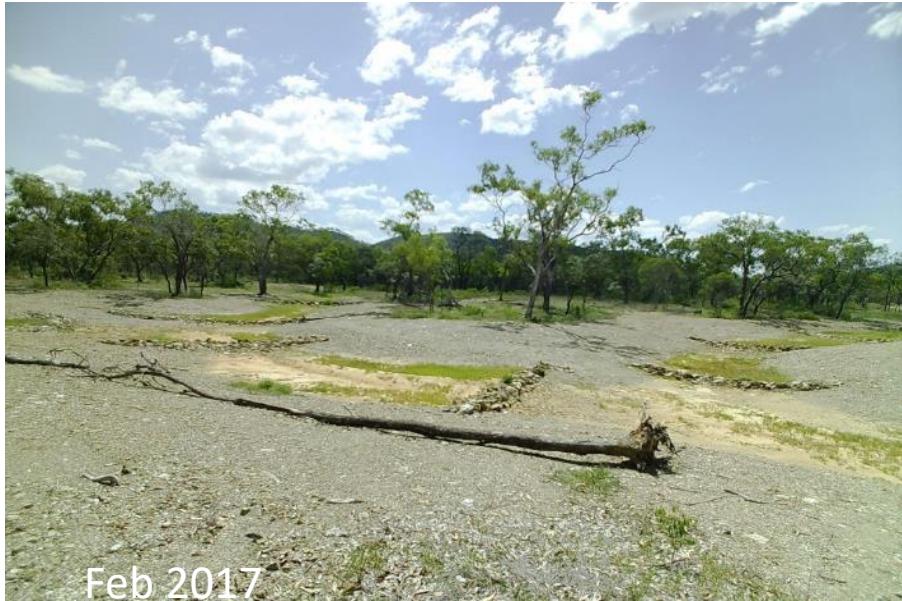
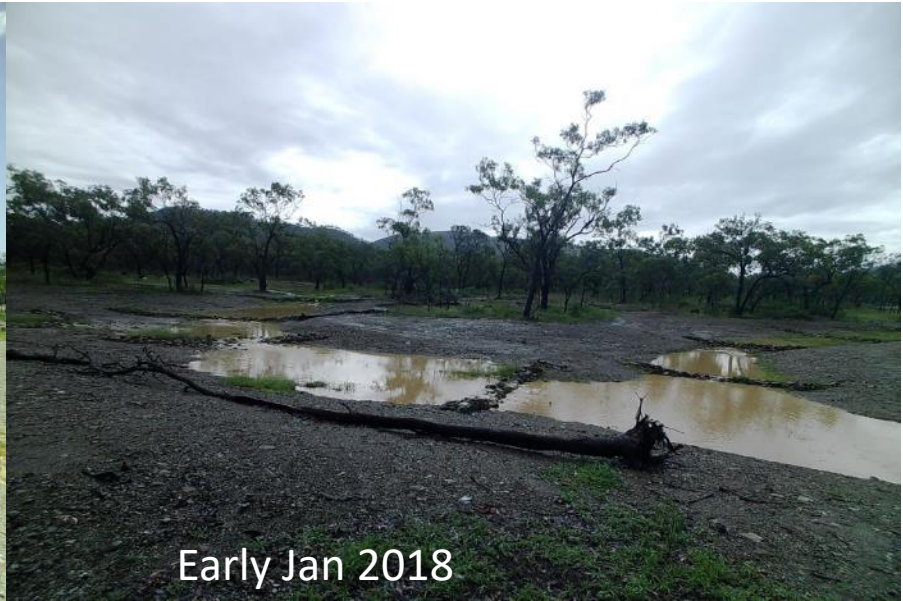
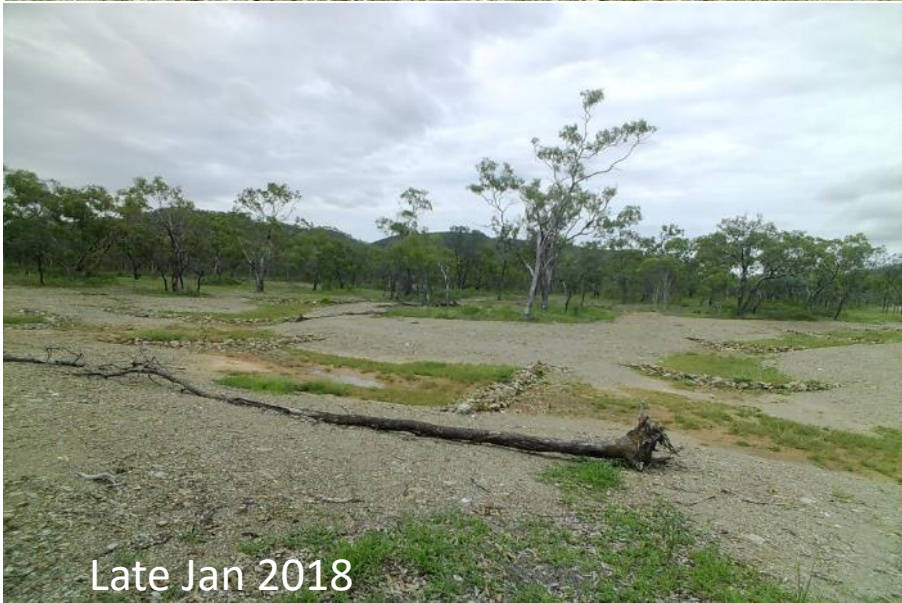
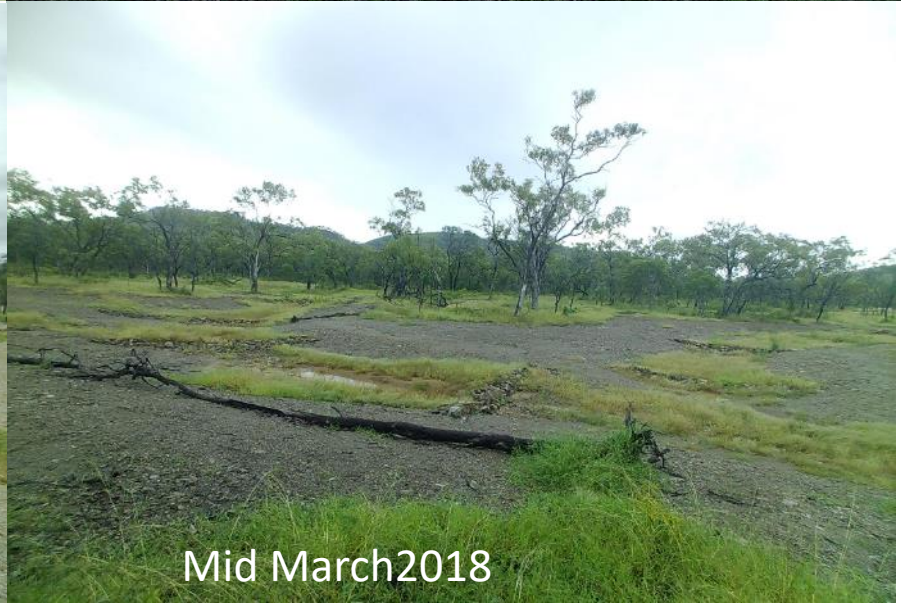
Feb 2017

Early Jan 2018

Late Jan 2018

Mid March 2018

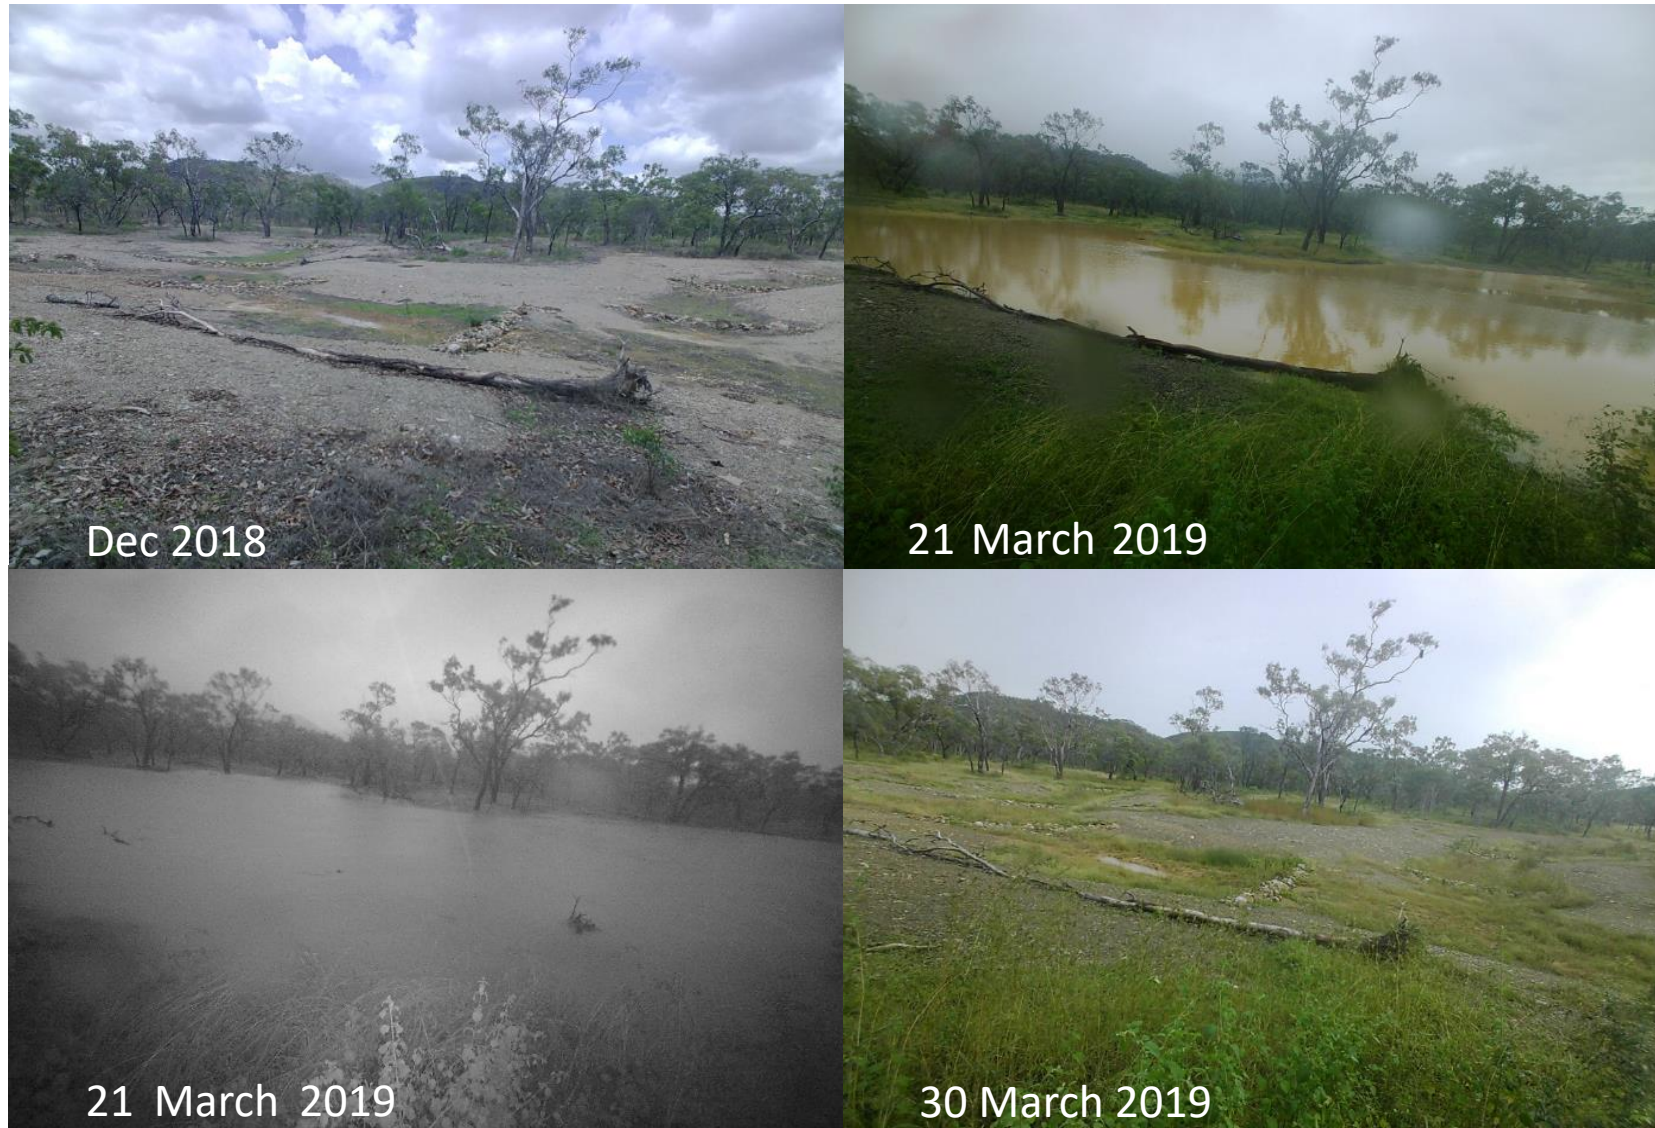
Figure 28. Sequence of post-construction rehabilitation of Crocodile Gully 2.234. Note the backwater event experienced in March 2019.

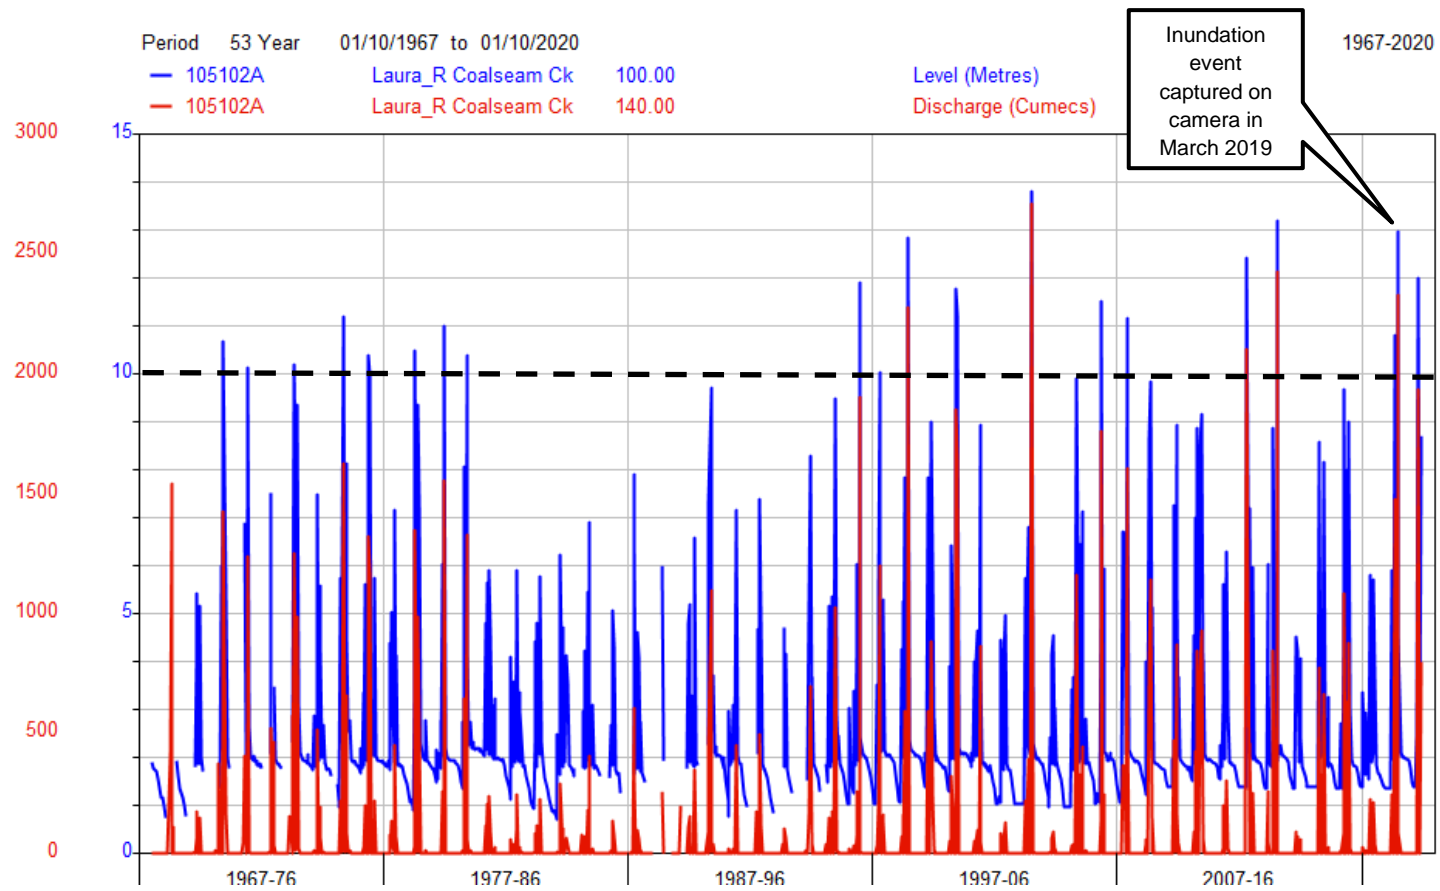
Figure 29. Flow record for the Coal Seam Creek gauge on the Laura River, 13km downstream of the Crocodile Station study site. The dashed line represents the approximate flow stage on the river at which the study site gullies begin to be inundated by river backwater.

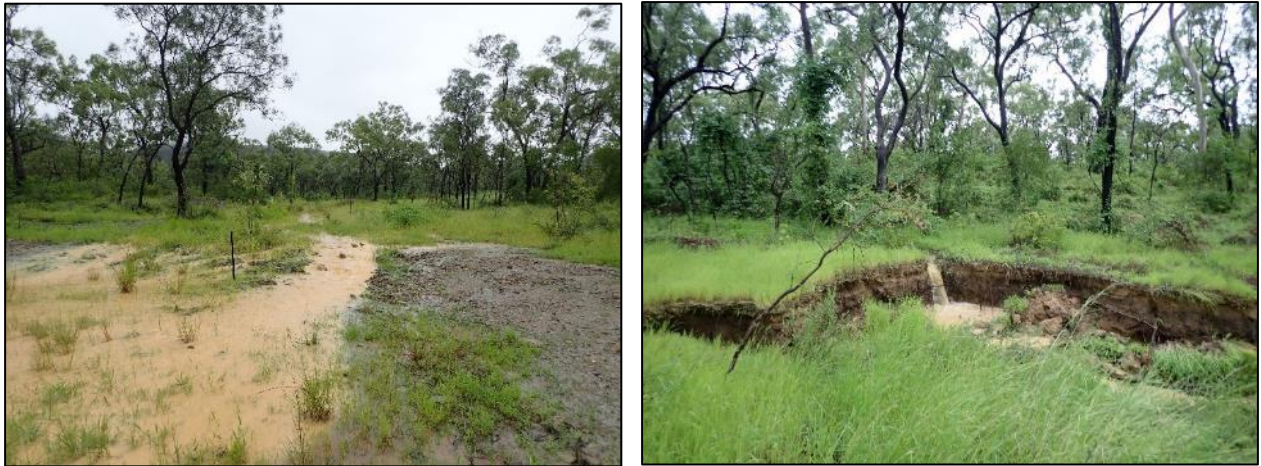
Figure 32. Catchment runoff flowing into gullies 2.234 (left) and Control (right). The brown colour of the water suggests fine sediment is being transported in the catchment runoff. Note, the left picture is facing upstream at the top of a remediated lobe on gully 2.234, whereas the right picture is facing up stream at water flowing into the head cut of the Control gully.

Visual observations made, during the 2018/17 wet season (Figure 32) of the water flowing from the catchments of gullies 2.234 and Control indicated that suspended sediment sourced from the catchments was being transported through the gullies. This meant that the SSC measurements of samples collected at the outlet of the gullies were likely measuring gully and catchment sourced suspended sediment together, thus biasing the measurement of sediment contribution from the gully. To confirm this several PASS samplers were deployed, during the 2018/19 wet season, in natural depressions throughout the catchments of gullies 2.234 (three PASS samplers) and Control (one PASS sampler) (Figure 3 and Figure 33).

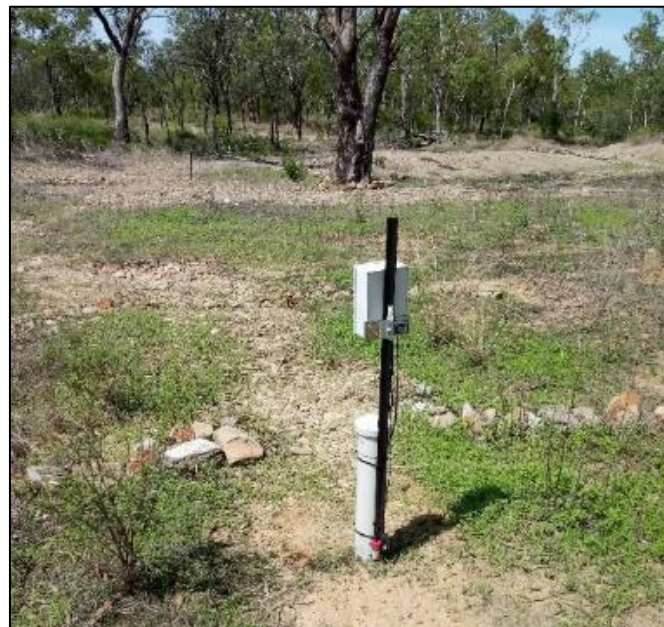
Figure 33. PASS sampler deployed in catchment upstream of remediated gully 2.234.

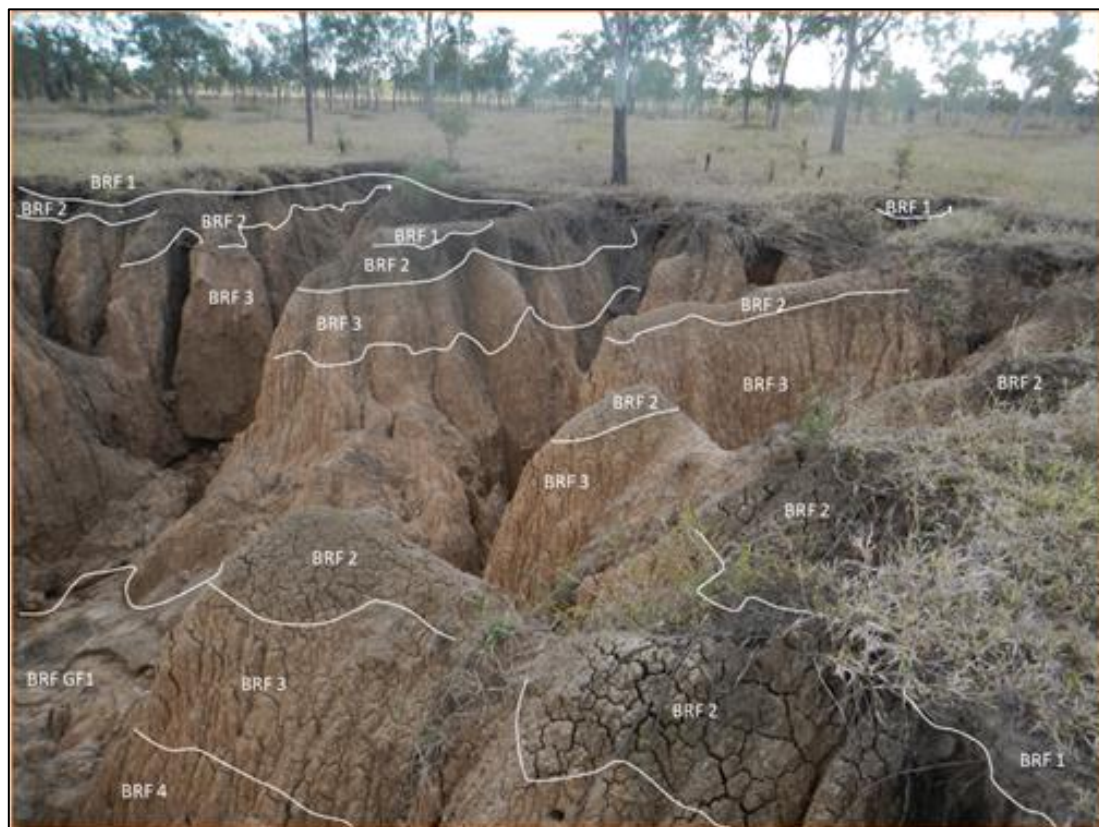
Figure 54. Soil-geomorphic layers (as SMUs) identified in Gully 7 at Strathalbyn Northern Gullies. As can be seen from this photograph the soil material layers vary, well below the depth of normal augering (1.2 m) and coring (1.5 m).

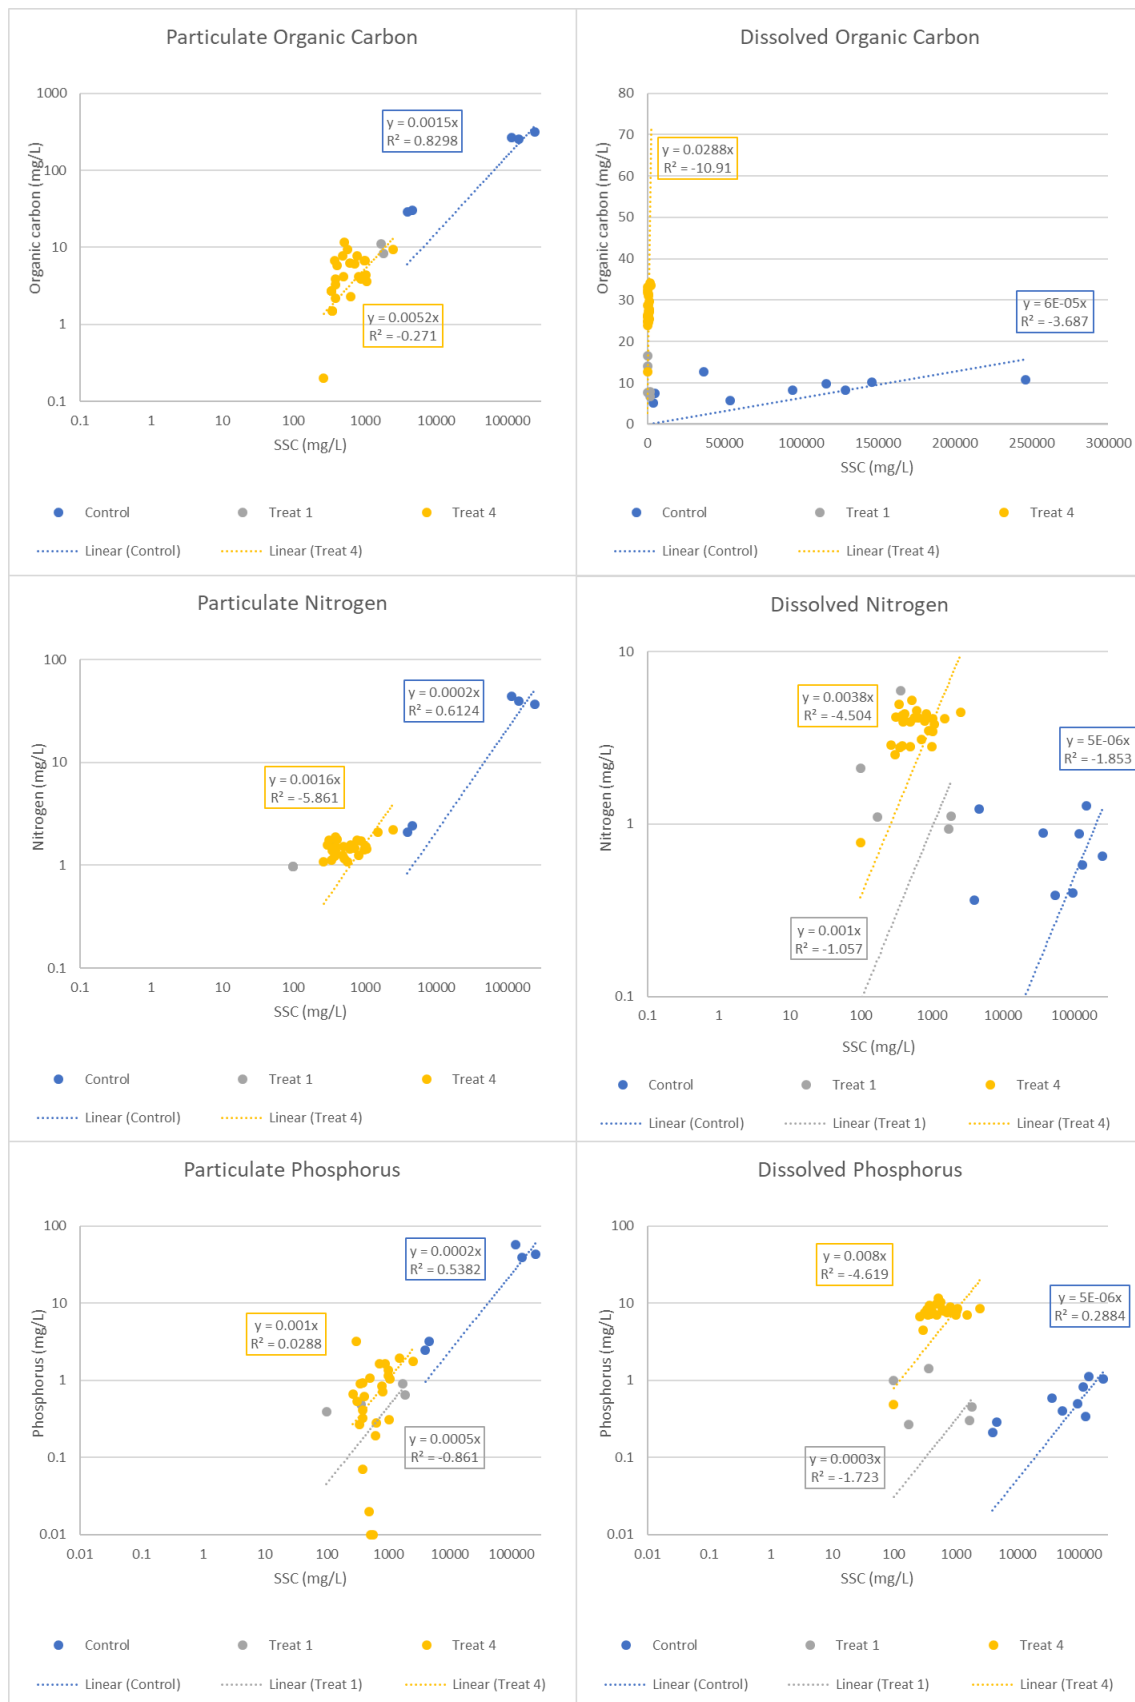
Figure 79. Relationships between SSC, organic carbon, and nutrient concentrations in the control (red) and remediated gullies T1 (grey) and T4 (yellow) from samples collected during multiple flow events for wet seasons 2018/19 and 2019/20

Evaluation of the relationship between nutrients and suspended sediment concentration indicate particulate nutrients have a moderate to strong relationship with suspended sediment in the Control gully (Figure 79). Whereas this relationship is not evident in the sample data collected from the remediated gullies. Dissolved nutrients appear to have no relationship with suspended sediment in the control, except for phosphorus which has a weak correlation with SSC. Dissolved nutrient sample data from remediated gullies also show no obvious trends except for the dramatic difference in sample concentration range and correlation slope between SSC and dissolved organic carbon. This influx of organic carbon, likely sourced from the added mulch and compost in the gully remediation structures, may be a factor influencing the biogeochemistry interactions within the gully system during flow events. Further investigation regarding this issue is currently underway.

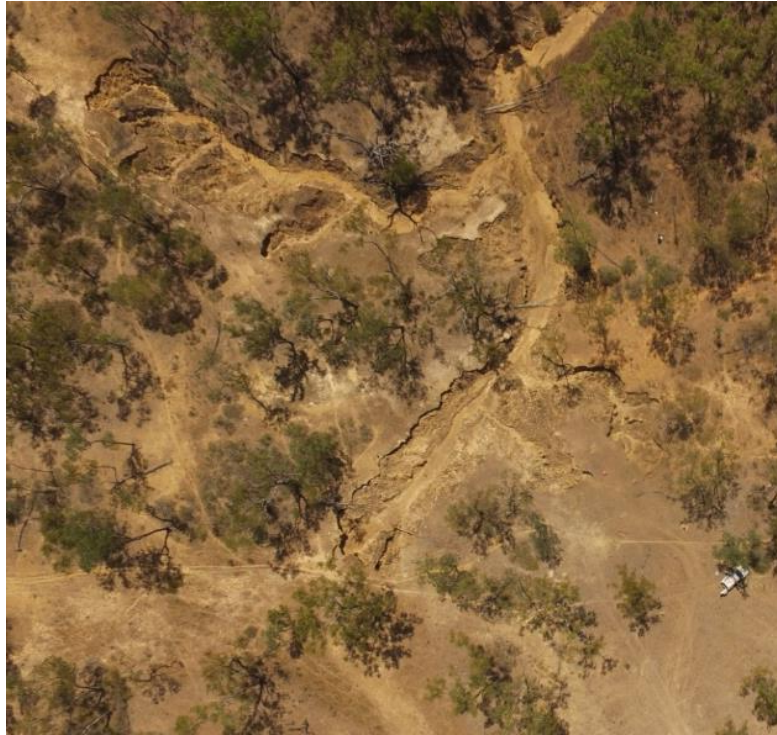
Figure A1.2. Aerial imagery of treatment site from September 2016
